Our Ancestral Country Allies: The Rubble Walls

Josianne Vella and Jesús Garrido
Integrated Resources Management (IRM) Co. Ltd.
Malta

The Story of the Maltese Rubble Walls

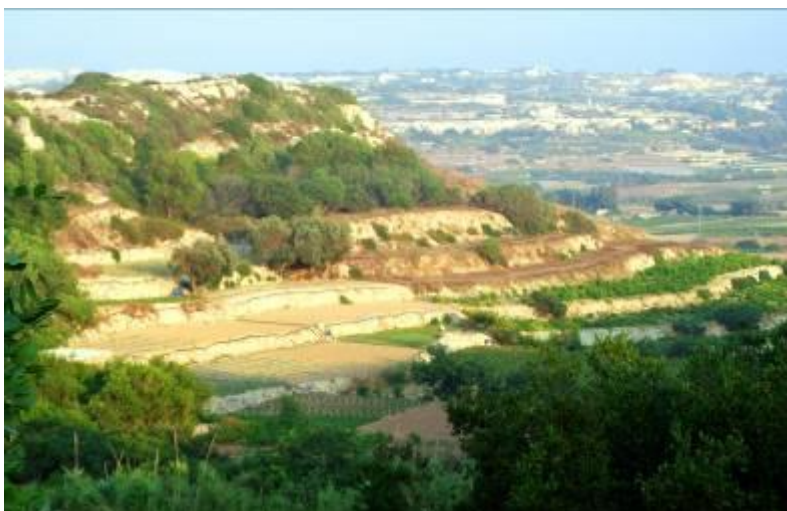
Fig.1: Terraced fields with rubble walls – the Maltese rural landscape (Wied Għemieri, Malta).

terraced fields allows for sloping areas to be cultivated and is also designed as a means to slow surface runoff and prevent the soil from being washed away. In Malta and Gozo, terracing supported by rubble walls has been used by the local farmers for many centuries.

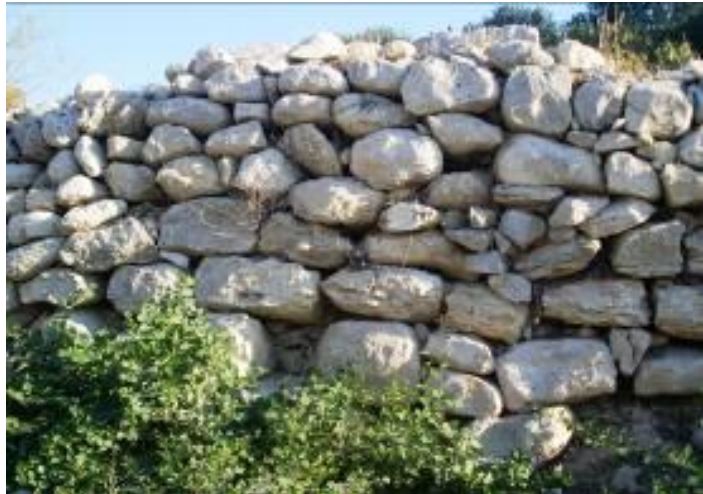
Fig.2: Rubble walls are 'dry' stone walls (Wied Qirda, Malta).

Rubble walls are 'dry' stone walls, that is, walls entirely built without the use of cement or mortar. Their stability comes from the skilful placing and fitting together of the stones. The use of basic 'dry' stone building can be traced back to prehistoric times and examples of 'dry' stonewalls and buildings can be found all over the world throughout history. In the Maltese Islands, early examples of 'dry' stonewalls can be seen around the entrances of the Megalithic Temples, dating back as far as 5000 BC, and also at the Bronze Age village of Borg in-Nadur.

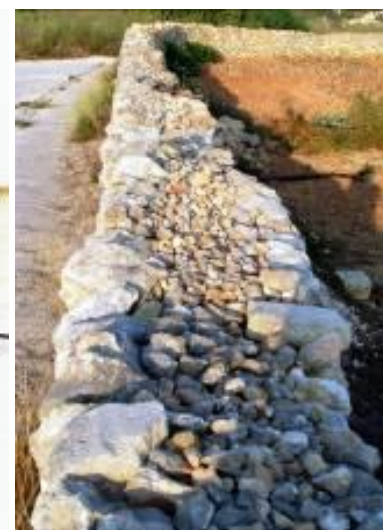
Fig.5: Rubble wall infill, '*mazkan*' (Wied Għomor, Malta).

A rubble wall is constructed as a double wall with an infill of tightly packed smaller stones, called '*mazkan*', in the centre. This gives strength to the wall, preventing it from collapsing inwards. The strength and stability of the wall also depends on proper foundations which, ideally, are laid directly on bedrock. The walls are built up to the desired height layer by layer, and at intervals, large tie-stones are placed which span both faces of the wall.

The building technique is mostly focused on protecting the wall from giving in under the pressure of surface runoff during rainfall events. Apart from strengthening the wall, the central infill is also extremely important in regulating the drainage of rainwater around and inside these walls. According to Ellul (2005), the stones used for the infill must be graded and laid down systematically with the larger stones placed at the base.

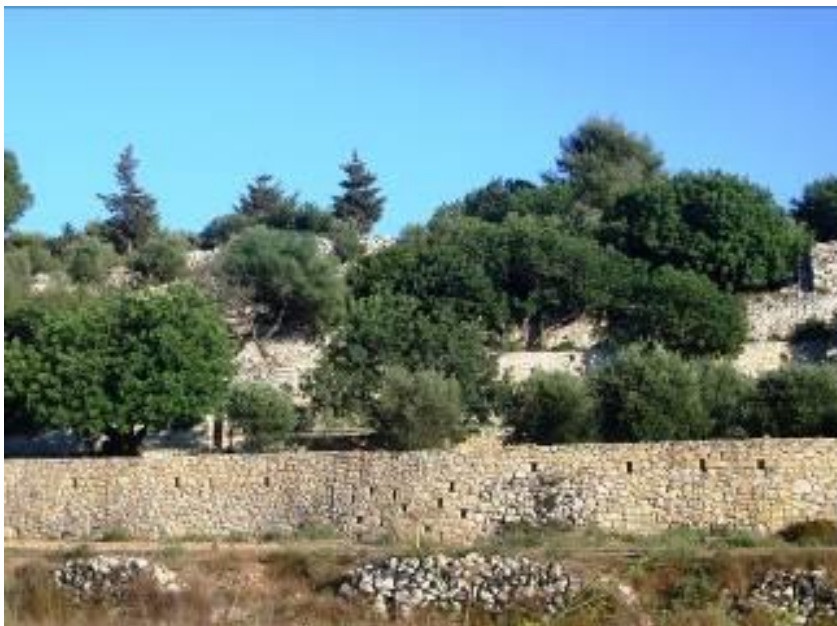
Fig.6: Flow holes in a rubble wall (Wied Qirda, Malta).

Fig.7: Detail of flow hole (Wied Qirda, Malta).

Additionally, flow holes can often be seen at the base of these rubble walls. Primarily these flow holes prevent the collapse of the walls by relieving the pressure of heavy storm water. They are mostly used in walls retaining clayey soils, since these soils tend to hold more water and expand, thus increasing the pressure on the surrounding walls.

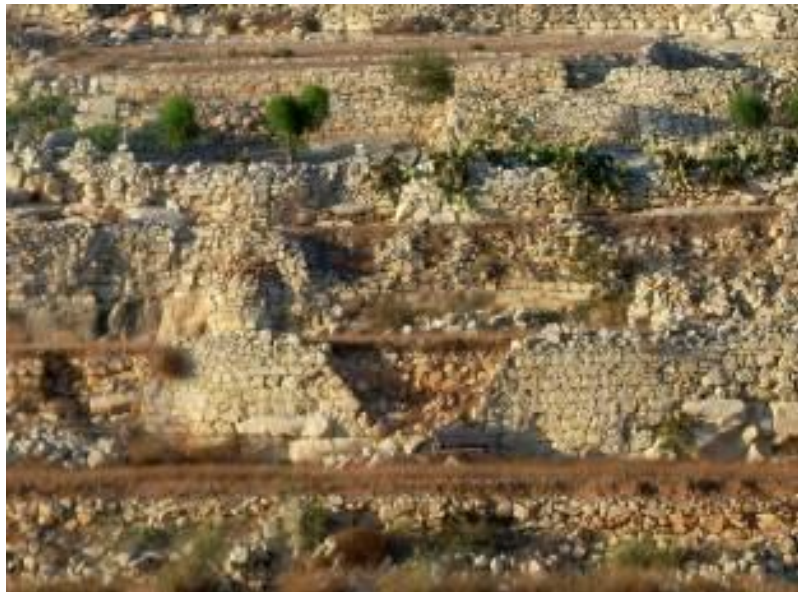
Fig.8: Rubble walls made up of ‘*Posta*’ and ‘*Ġwienaf*’ (Wied il-Kbir, Malta).

The building of longer walls, or those retaining terraces, requires more skill. Ellul (2005) notes that longer walls are usually constructed of independent “V” sections locally known as ‘*posta*’ and ‘*ġwienaf*’. Therefore if a ‘*posta*’ collapses the adjacent section will not because it is not directly connected to it. Similarly, for walls retaining terraces, special considerations need to be taken with respect to the foundations, the infill and the inclination of the wall.

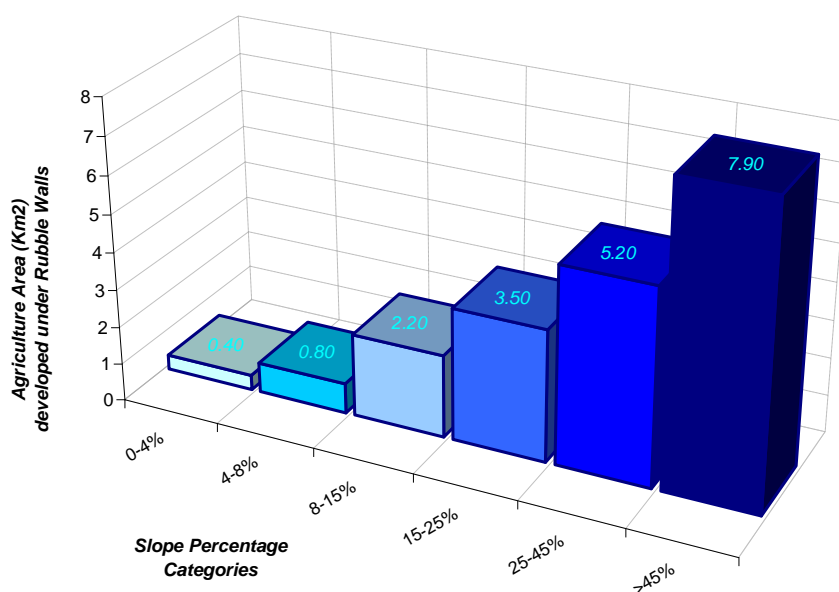
Fig.9: Graphical representation of figures presented in Table 1.

Agriculture is important for the economy of Gozo. In fact, 48.4 km² is arable land, which represents 72% of the island. Nearly half of this arable land, 20 km², is taken up by terraced fields supported by rubble walls. Figure 9 shows that the majority of these rubble walls are found along the steepest slopes on the island. This highlights the importance of rubble walls in **maximising the surface area available for agriculture** in hilly areas.

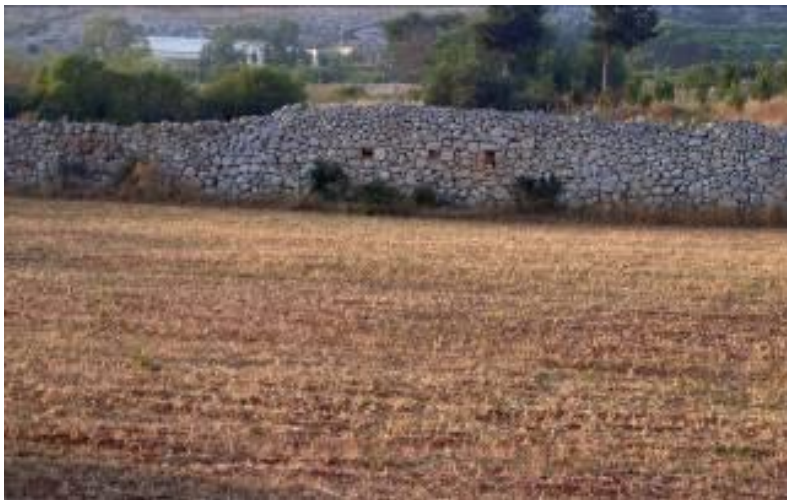
Fig.10: Stubble, an important agricultural input for soil formation (Wied Ghomor, Malta).

soil are not yet well developed. The process of soil formation requires time for the soil horizons to reach the best edaphological characteristics. Rubble walls support the conditions required for soil formation in that they allow for crops to be cultivated and help in retaining soil moisture. In the long-term, the inputs of crop residues (roots, stubble etc.) and natural fertilizers build up the characteristics of the soil, consequently increasing its productivity. Therefore, if the field created behind the

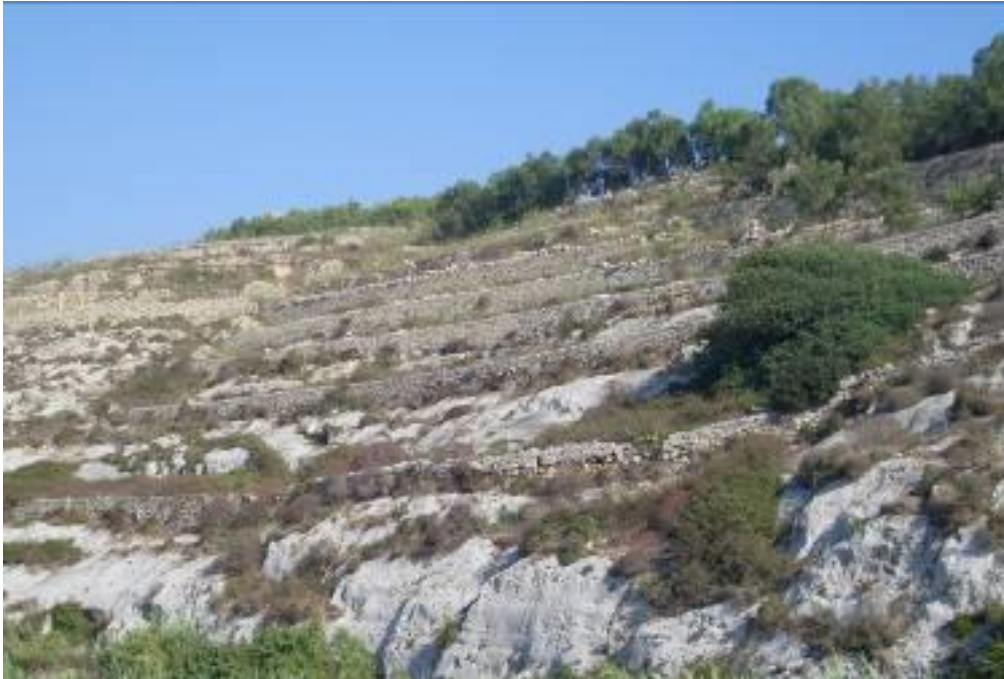
Fig.15: Terraced fields cutting through a steep slope (Xlendi Valley, Gozo).

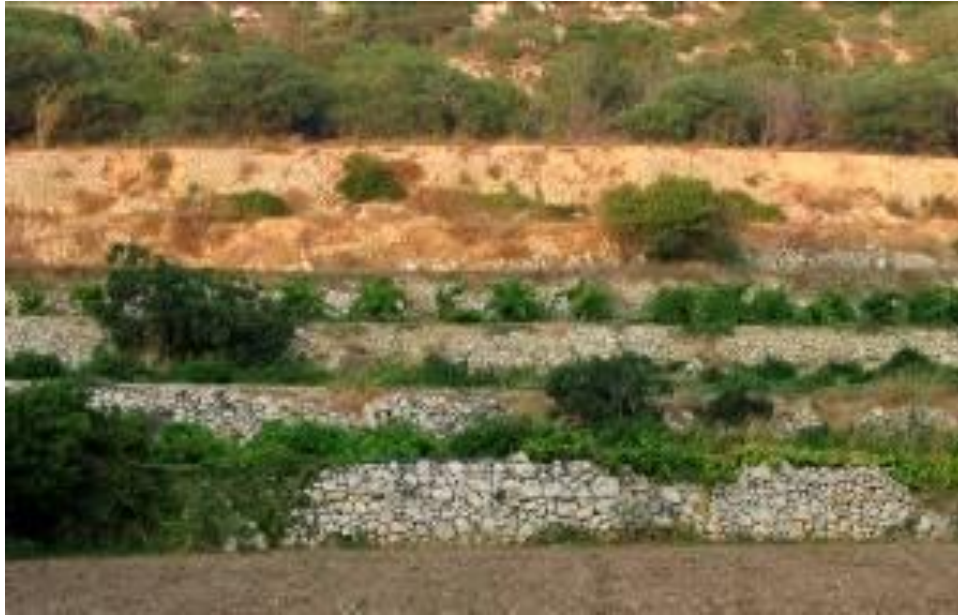
Fig.16: Soil slumps are observed in the upper terrace. Lower terraces show better maintained rubble walls (Wied Għemieri, Malta).

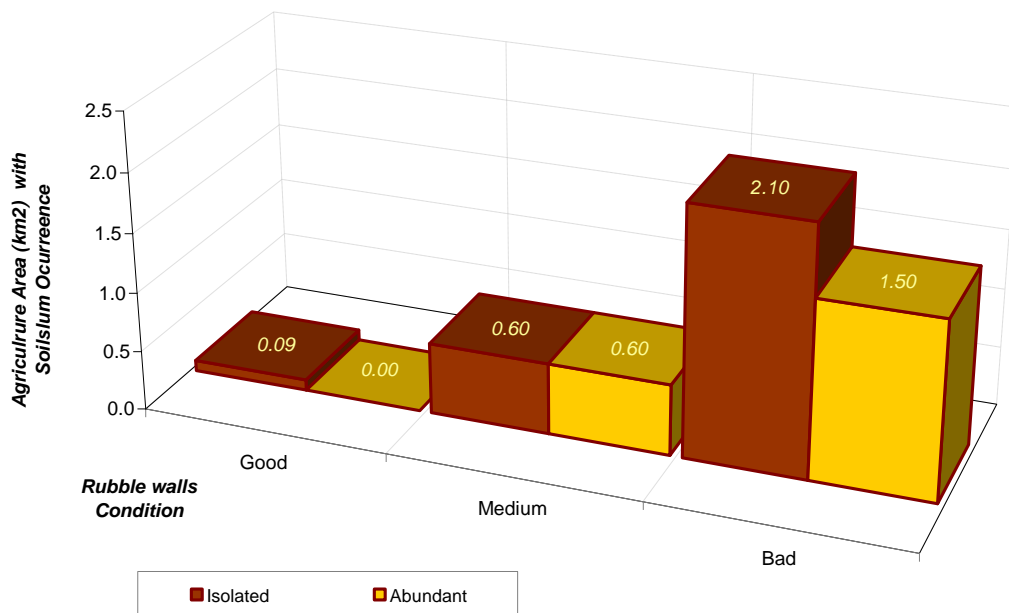
Fig. 17: Graphical representation of the information presented in Map 2.

As shown in Map 2, the occurrence of soil slumps correlates extremely well with the condition of the rubble walls on the island. The map clearly reveals that rubble walls in poor condition were found predominantly in areas where a high incidence of soil slumps had been recorded. Figure 17 confirms that walls in good condition presented practically no soil slump occurrence. Both illustrations highlight the significance of well-maintained rubble walls as a conservation practice to combat soil movement and soil loss.
